Inspection Report

Milwaukie OR 97222

Home Inspector:

Date: 8/22/2015	Time: 08:30 AM	Report ID: Report
Property: Milwaukie OR 97222	Customer:	Real Estate Professional: Premiere Property Group

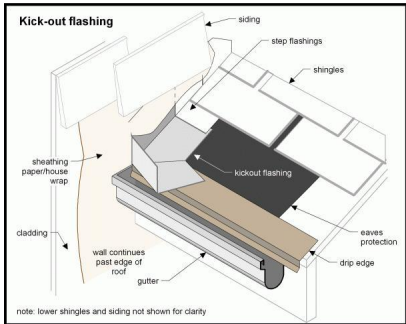
1.1 Item 1

1.1 (1) There are areas on the roof where the covering meets the wall that has improper kick- out flashing to direct water away from the structure. I recommend flashing installed in these areas to prevent possible water intrusion.

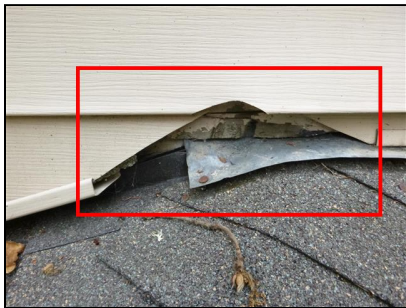
1.1 Item 5

1.1 (2) There are areas on the roof where the siding and flashing are not covering the wood sheathing underneath. This exposes the wood to rain. I recommend having these areas covered properly with weatherproof material.

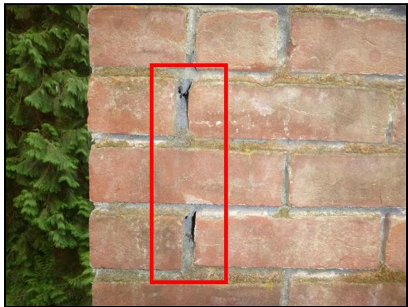
1.2 Item 1

1.2 There are areas of the chimney where the mortar has crumbled away leaving gap openings to the flue. I recommend having a licensed mason repair as needed.

There are areas of the chimney where the mortar has crumbled away leaving gap openings to the flue. I recommend having a licensed mason repair as needed.

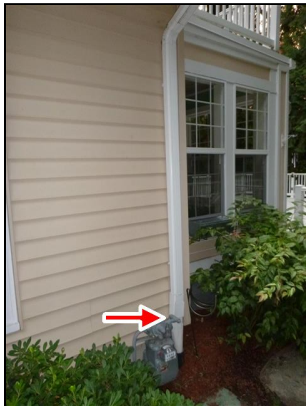
1.3 Item 1

1.3 There is a downspout that is partially disconnected from the below ground drainage extension. I recommend having all downspouts seated properly to direct water into the below ground drainage system.

There is a downspout that is partially disconnected from the below ground drainage extension. I recommend having all downspouts seated properly to direct water into the below ground drainage system.

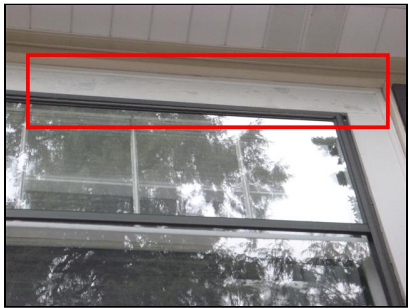
2.0 Item 1

2.0 (1) **Improve:** There is paint failing on wood trim around the house. I recommend applying a fresh coat of exterior paint.

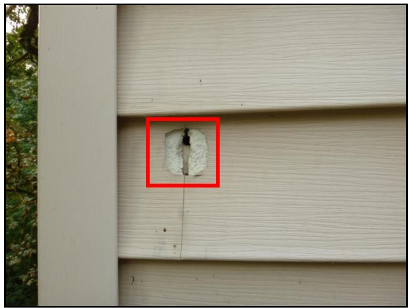
2.0 Item 3

2.0 (2) There is a small hole in the vinyl siding on the stream side of the house exposing foam and sheathing. I recommend having all holes, gaps, or openings in the siding covered properly with weatherproof material.

(2) There is a small hole in the vinyl siding on the stream side of the house exposing foam and sheathing. I recommend having all holes, gaps, or openings in the siding covered properly with weatherproof material.

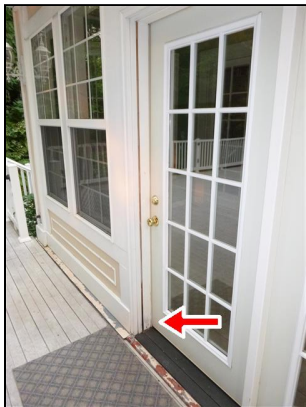
2.1 Item 1

2.1 (1) The french doorway on the deck side of the house has some slight rot at the base of the left door jamb.

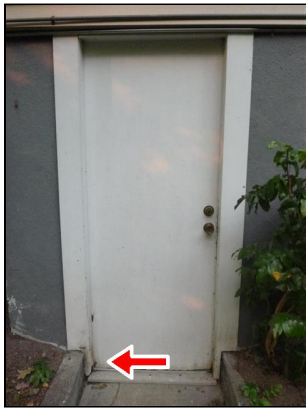
2.1 Item 3

2.1 (2) The exterior basement door has some rotting of the jam (exterior and interior sides) and its thin surface sheathing is loose. I recommend monitoring this area closely during heavy periods of rainfall to determine if any standing water issues exist.

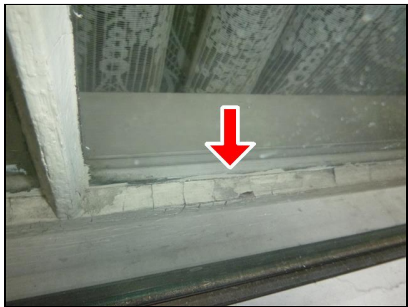
2.2 Item 1

2.2 The older windows behind the storm windows have peeling paint in some damaged wood around the muntins. I recommend having the old windows inspected further by a licensed contractor who specializes in window repair or replacement. Repair or replace as needed.

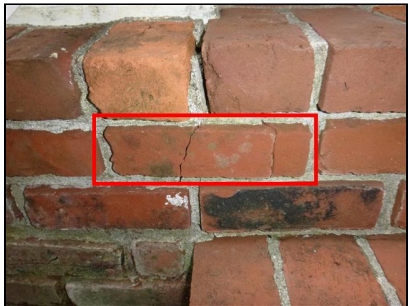
2.3 Item 1

2.3 (1) There is some spalling (crumbling) and cracked brick at the front door entry.

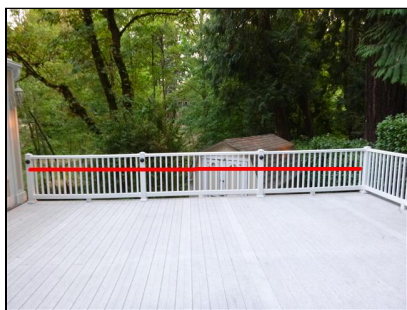
2.3 Item 4

2.3 (2) There is a section of the deck railing that is slightly loose. I recommend securing the rail tighter.

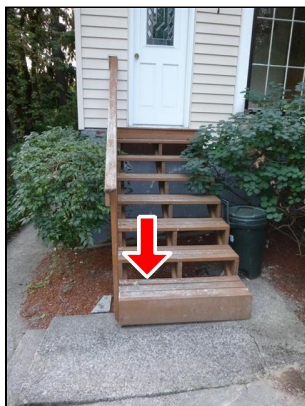
2.3 Item 7

2.3 (4) The west side wood steps to the side entry door is losing its weather protection coat. I recommend applying weather sealing to the wood for proper preservation.

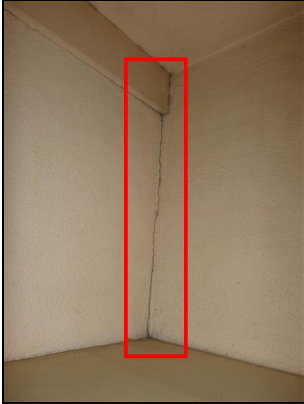
3.0 Item 1

3.0 Monitor: There are settlement cracks throughout parts of the house in the ceiling, walls, and widow sills. These are common when the structures framing shifts overtime and settles moving the drywall and finishing with it. If the cracks increase in size or length in a short period of time I would recommend consulting a licensed professional to evaluate further. Otherwise the structure appears stable.

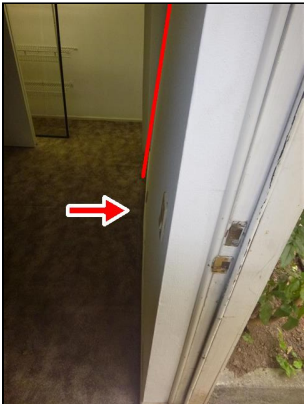
3.1 Item 1

3.1 The exterior side wall in the basement room with the exterior entry door is bulged and slanting abnormally.

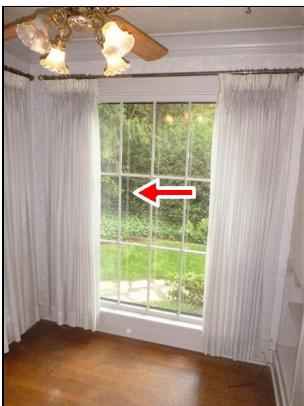
3.6 Item 1

3.6 (1) There is a cracked pane of glass in one of the old windows on the south west side of the house.

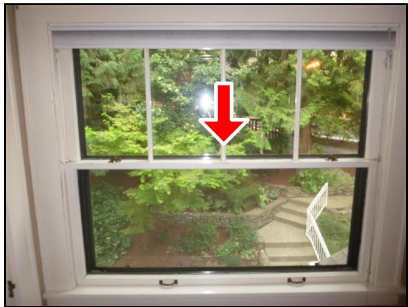
3.6 Item 3

3.6 (2) The big single hung window in bedroom 2 does not stay open and has a severed rope pulley. I recommend having licensed professional who specializes in old windows inspect the windows further. Repair or replace as needed.

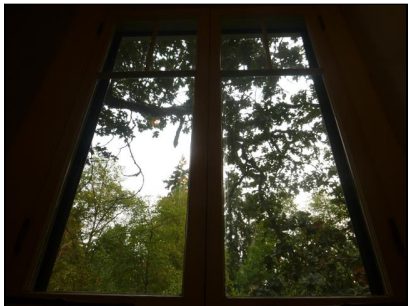
3.6 Item 5

3.6 (3) There are windows upstairs that have no locking mechanism.

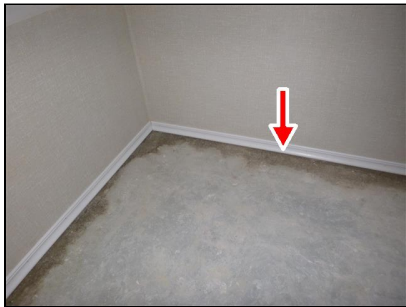
4.0 Item 1

4.0 (2) There is some water staining on the floor in the basement which could indicate there was or is a water intrusion issue. I recommend monitoring the basement closely during heavy periods of rainfall to determine if there are any existing water intrusion issues.

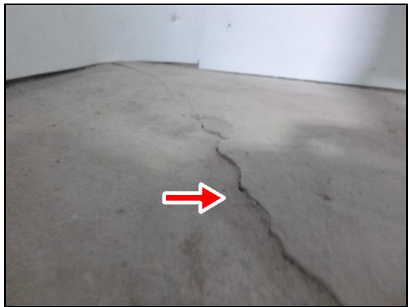
4.3 Item 1

4.3 (1) The flooring in the sunroom is not level. There is a slope toward the outside deck.

4.3 (2) There appears to be some shifting of the ground underneath the structure in multiple places causing over time the concrete flooring to crack and pushed upward. I recommend having a licensed structural engineer inspect the foundation and wall further to determine proper stability.

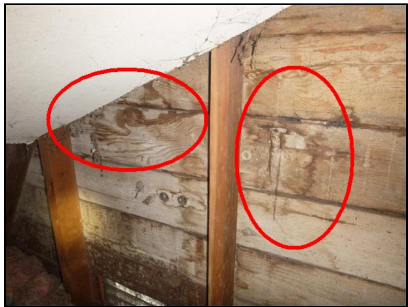
4.5 Item 1

4.5 (1) There are water stains in the attic space that could indicate a leak somewhere in the roof or framing. I cannot determine if these stains were caused by an old issue or current one. I recommend monitoring the attic space closely during heavy periods of rainfall to determine if any water intrusion issues exist. If they do I recommend calling a licensed professional to repair as needed.

(1) There are water stains in the attic space that could indicate a leak somewhere in the roof or framing. I cannot determine if these stains were caused by an old issue or current one. I recommend monitoring the attic space closely during heavy periods of rainfall to determine if any water intrusion issues exist. If they do I recommend calling a licensed professional to repair as needed.

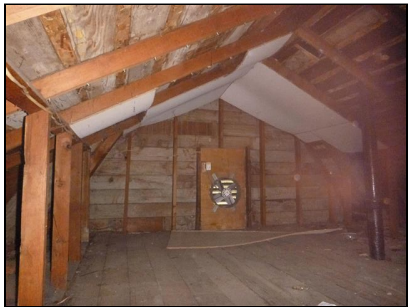
4.5 Item 5

4.5 (2) The areas of the attic space that I could observe appeared to be in good condition with no visible indication of mold, dry rot, or wood destroying organisms at the time of the inspection. While I make every effort to identify potential problems that may exist there may be areas that were hidden by insulation or obstructed buy wood placed on the framing.

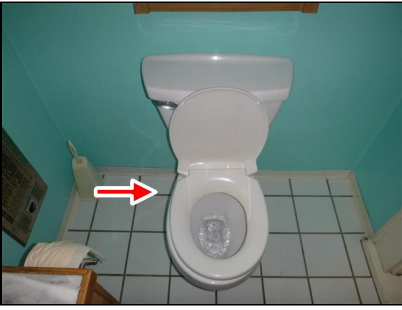
5.1 Item 1

5.1 (1) The toilet in the side entry room near the kitchen is very loose from the securing bolts. I recommend checking the sheathing underneath the linoleum for any evidence of water damage from a compromised wax ring and having the toilet secured tightly to the ground.

(1) The toilet in the side entry room near the kitchen is very loose from the securing bolts. I recommend checking the sheathing underneath the linoleum for any evidence of water damage from a compromised wax ring and having the toilet secured tightly to the ground.

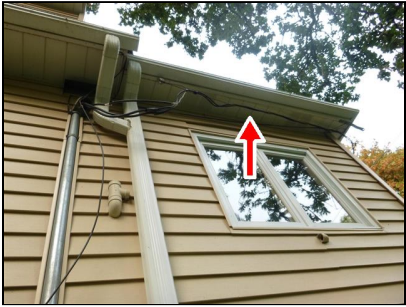
6.0 Item 1

6.0 The service entry wires appear too close to the side entry door and window. I recommend having a licensed electrician relocate the service entry wires appropriately if needed.

The service entry wires appear too close to the side entry door and window. I recommend having a licensed electrician relocate the service entry wires appropriately if needed.

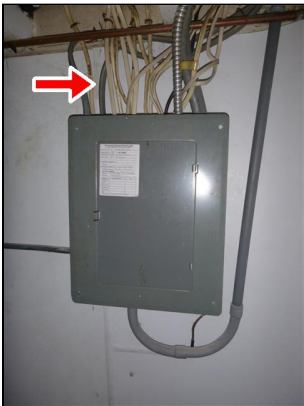
6.1 Item 1

6.1 Observation: The branch circuit wiring is exposed without conduit.

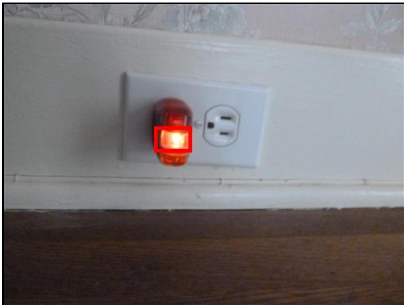
6.3 (1) There are ungrounded outlets throughout the house. This can be a safety hazard. I recommend having all the outlets in the house grounded properly by a licensed electrician as desired.

6.3 Item 1 Single yellow light indicates "Open Ground"

(1) There are ungrounded outlets throughout the house. This can be a safety hazard. I recommend having all the outlets in the house grounded properly by a licensed electrician as desired.

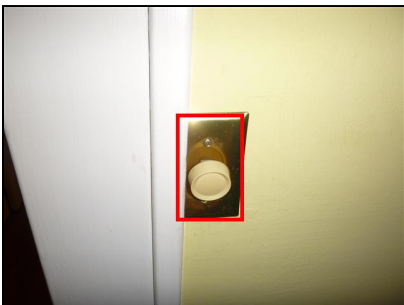
6.3 Item 2

6.3 (2) The upstairs bedroom light switch knob turned on the lights but was very loose and did not dim or brighten properly.

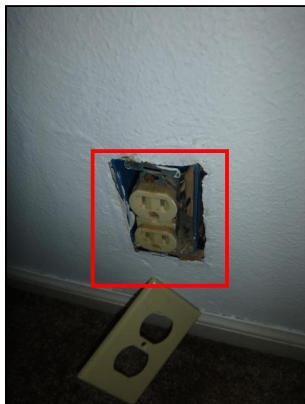
6.3 Item 3

6.3 (3) There is an electrical outlets in the basement that are not covered. I recommend having all electrical outlets and boxes properly covered for safety.

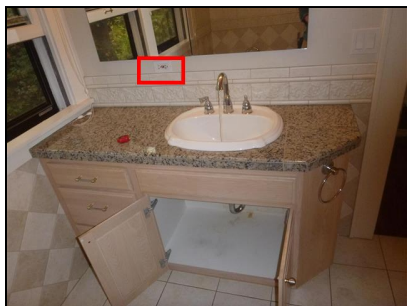
6.4 Item 1

6.4 There are no ground fault circuit interrupters (GFCI) outlets in the kitchen or mid-level bathroom near the sinks. I recommend replacing the current outlets with properly functioning GFCI outlets for safety.

There are no ground fault circuit interrupters (GFCI) outlets in the kitchen or mid-level bathroom near the sinks. I recommend replacing the current outlets with properly functioning GFCI outlets for safety.

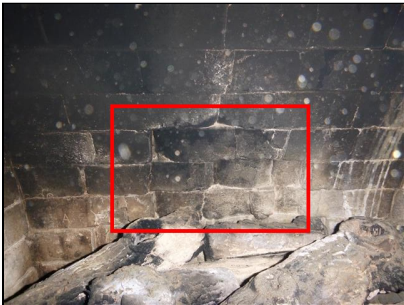
7.6 Item 1

7.6 There is crumbling brick inside the fireplace firebox and excessive creosote build up in the throat and flue. I recommend having the fireplace with all of its related components serviced by a licensed professional.

There is crumbling brick inside the fireplace firebox and excessive creosote build up in the throat and flue. I recommend having the fireplace with all of its related components serviced by a licensed professional.

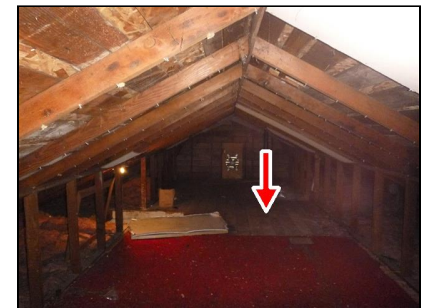
8.0 Item 1

8.0 Limitation: There is wood placed over the ceiling joists. I could not inspect under this would.
